NISTUNE TECHNICAL BULLETIN #002

TITLE : Correction of ECU Air Flow Meter modifications

Models covered: HR31, RB20DET, CR31 RB30E, VLT RB30ET, Z31 VG30E/ET (1986-1987)

Date: 25 September 2009

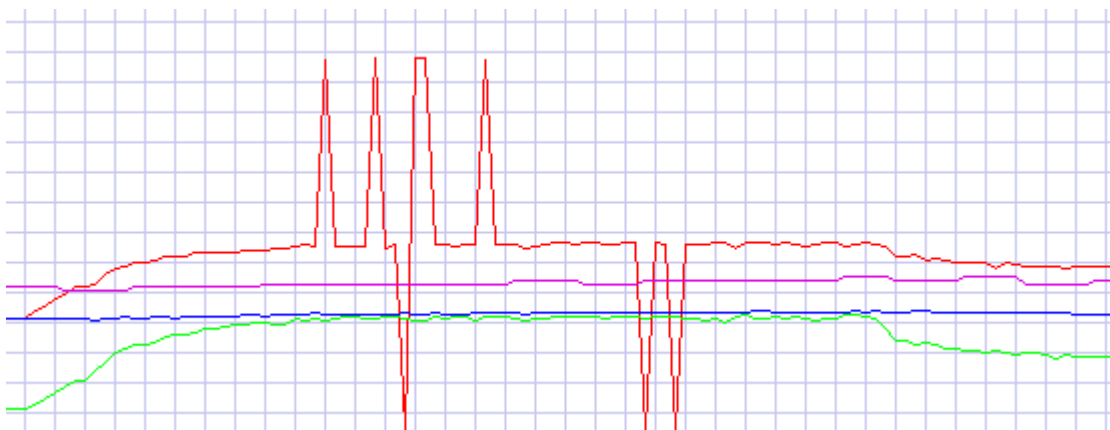
Following this modification it has been noticed during field testing that logs have indicated that 0 and 5 volt spikes in the AFM signal received by the HD46510 chip have been received and processed as can be seen below:

The removal of the opamp from the circuit has affected filtering of the ECU and occasional spikes in the fuel injection could be potentially noticed. In the log above TP was not affected, so the map points accessed were not changed.
